TN 904-5

Subject: Shaft-coupling in pump-unit

Affected:: E1 Antares, 1 to 60E49

Date: 20.03.2014

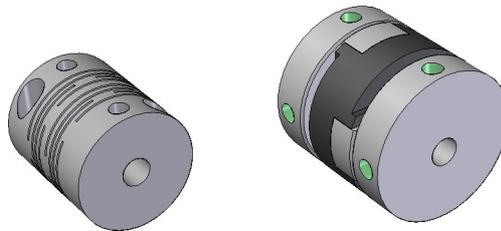
If the installed coupling is identical to coupling (1) in the picture above, then this must be replaced. If the installed coupling is identical to coupling (2) in the picture above, then the procedural steps 4e to 8p are skipped.

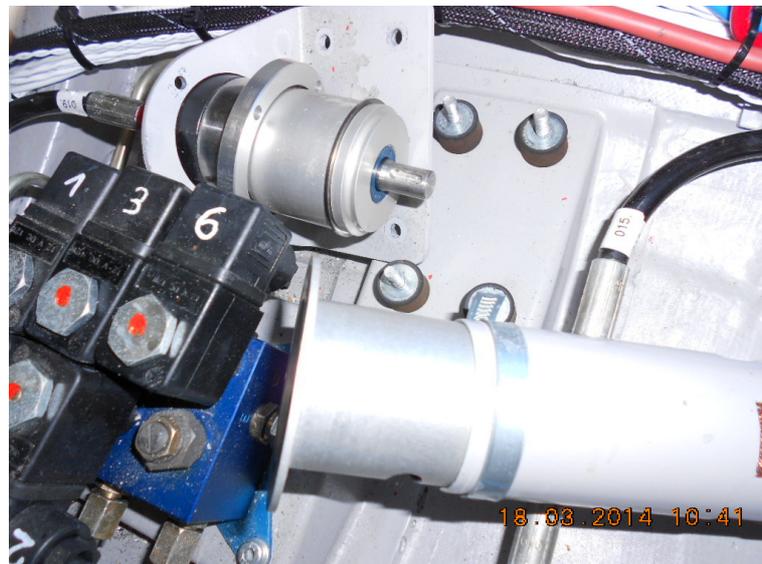
e. Inspect the shaft ends. Look for contamination and scratches.
If required; clean and remove protrusions.

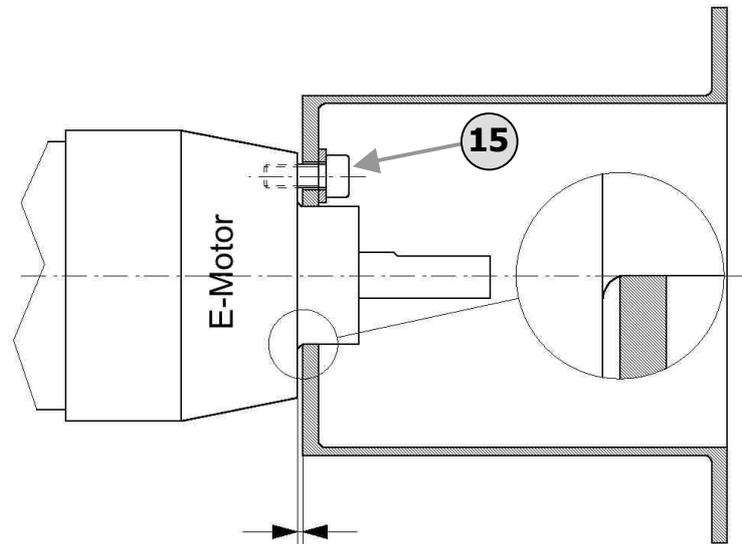
Check whether there is a gap between the motor and the coupling enclosure. If this is the case, then use a 2 mm Allen wrench to remove the four M3 x 8 screws (15), which connect the motor and the coupling enclosure.

Separate the motor from the coupling enclosure and use a 90° countersink tool to fit the edge of the coupling enclosure to the radius at the motor. Before re-assembly: check the length of screws (15) (Screw length should be 8 mm). Re-install the motor. Use medium strength threadlocker (Loctite 243) on the screws and apply inspection lacquer
