TN 904-4

Subject: Retrofit of capacitor-PCB

Affected: E1 Antares, factory Nr. 01 to 69E52, 900, 901

Date: 20.03.2014

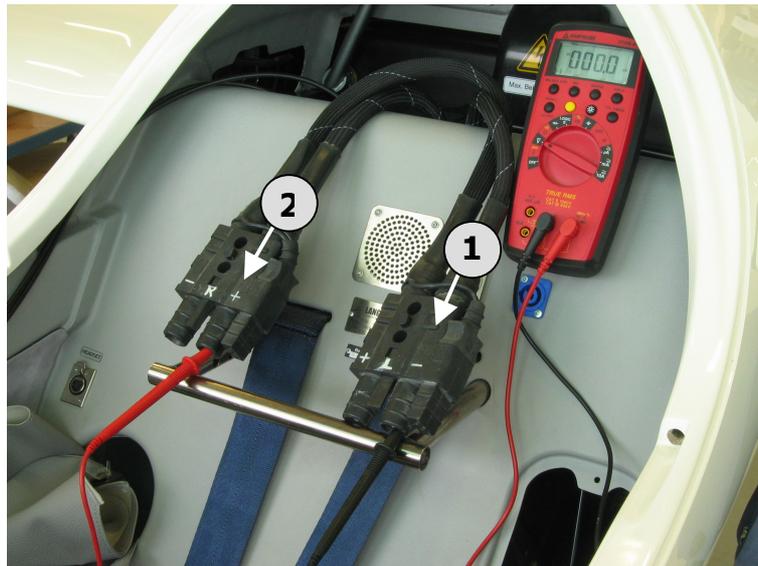
Use a Voltmeter to measure the voltage between the minus connector (1) of the left wing connector and the plus connector (2) of the right wing connector. Set the voltmeter to measure DC voltages at a 300V range. Take note not to measure against the bridging cable, which connects the right wing connector with the left wing connector. The measured voltage should not be above 2 V. Should a higher voltage be

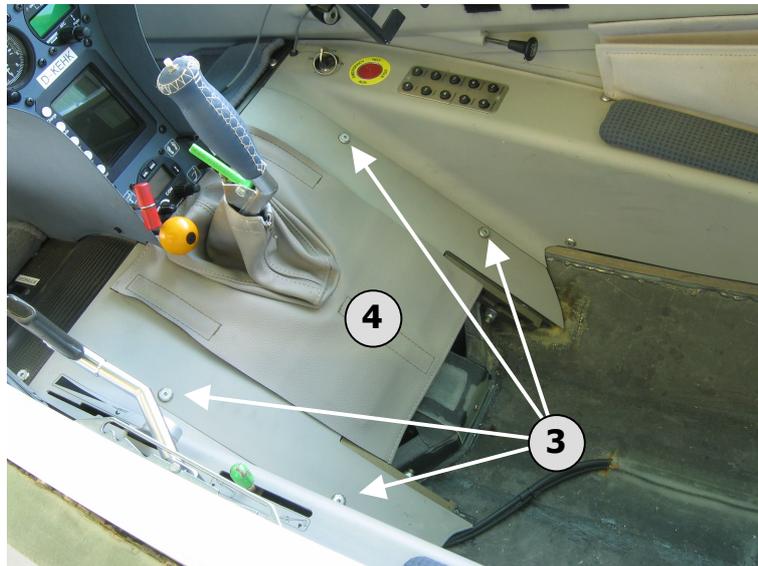
Use a 3 mm Allen wrench to remove the four M5 countersunk screws including collars (3) that are used to mount the upper leg-rest (4). Put the screws aside. Remove the upper leg-rest as well as the leather stick-cover.

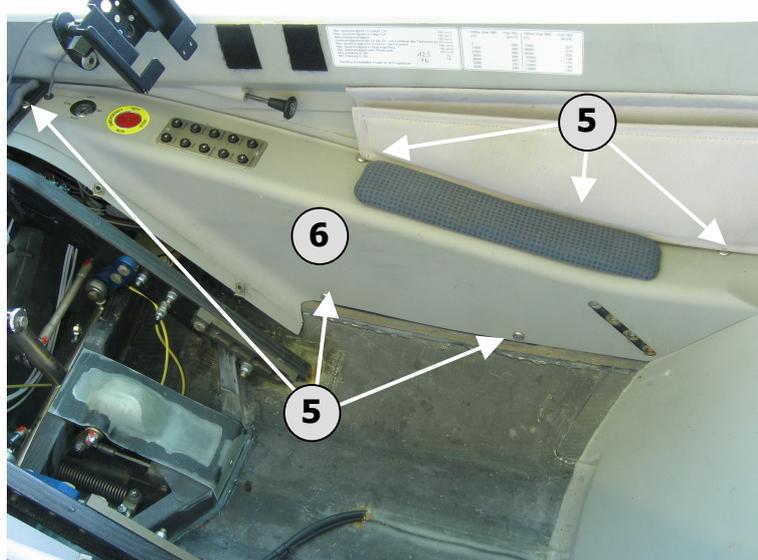
Use a 3 mm Allen wrench to remove the six M5 countersunk screws including collars (5) that are used to mount the side panel (6). Put the screws aside. Remove the side panel.

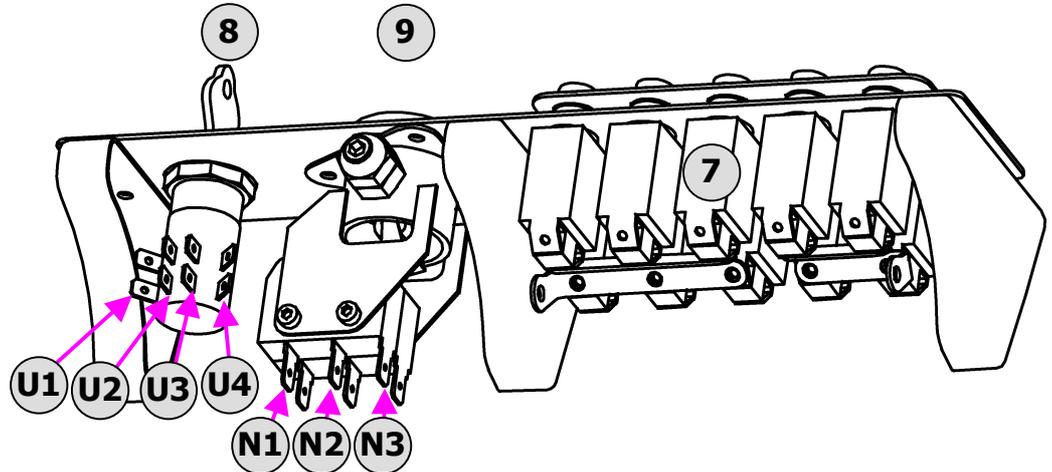
In addition to circuit breakers (7), the now uncovered circuit breaker panel contains the key-switch (8) and the emergency-off-switch (9).

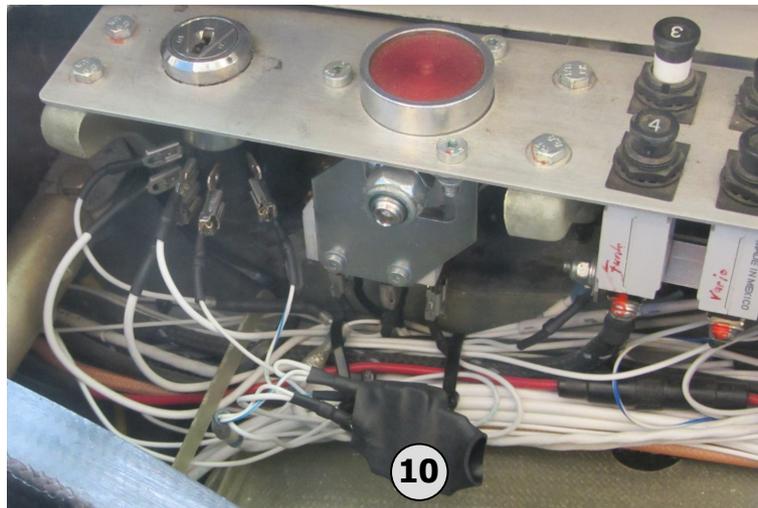
- e. Start by identifying the key-switch plug positions (U3) and (U4). Trace the cables that are connected to these plug positions.

- f. If these cables lead directly to a PCB (10) that has been covered by heat-shrink tube, then the capacitor PCB has already been installed, and subsequently procedural steps 3, 4

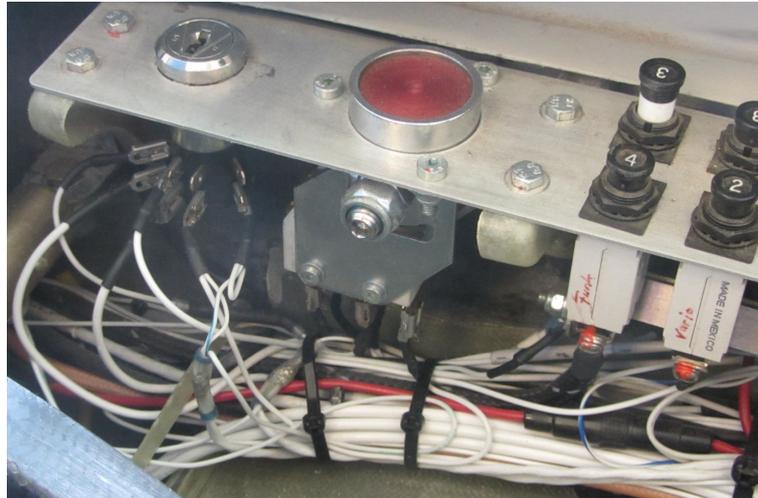
- g. If these cables do not lead directly to a PCB that has been covered by heat-shrink tube, but rather continue straight along the cable tray as depicted above, then continue with procedural step 3.
3. Install capacitor PCB
The capacitor PCB is installed at a pre-existing disconnection point on the affected wire. This disconnection point is located in the vicinity of the power electronics for the propulsive motor.

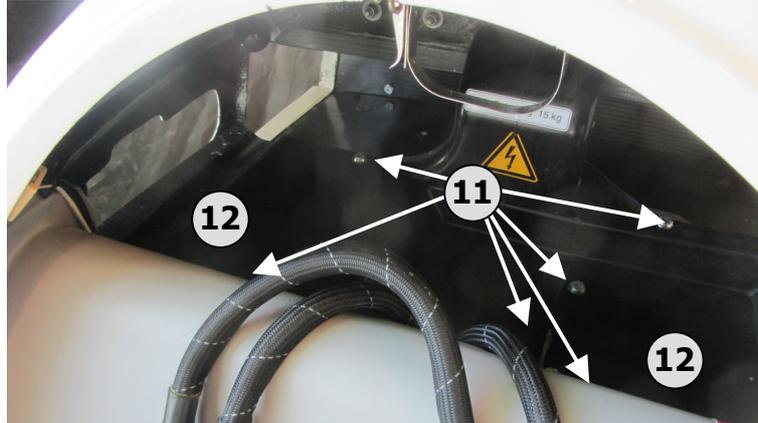
Use a 3 mm Allen wrench to remove the six M5 countersunk screws including collars (11) that are used to mount the baggage compartment floor (12)

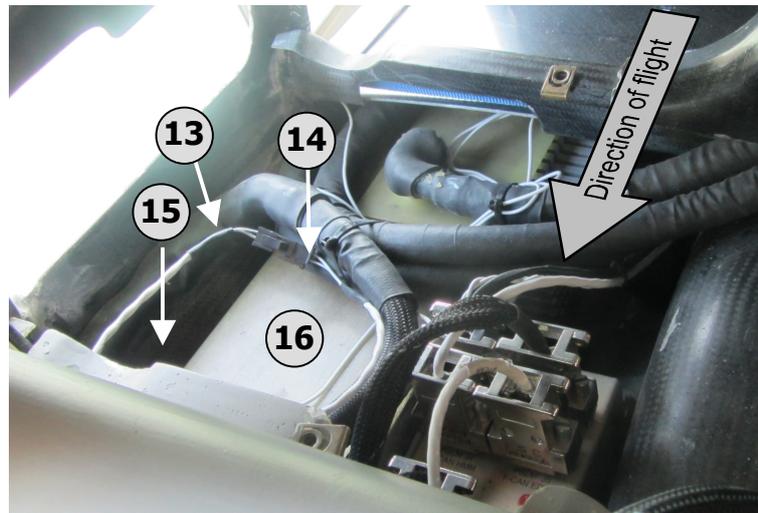
Use the picture above to identify the cable (13) and the disconnection point (14). If this wire can not be identified immediately, then it is possible that it is located in the space (15) between the power electronics (16) and the right-hand fuselage shell. The routing of the cables may differ from the picture, but there is only one disconnection point in this area. This eliminates the danger of incorrect identification.

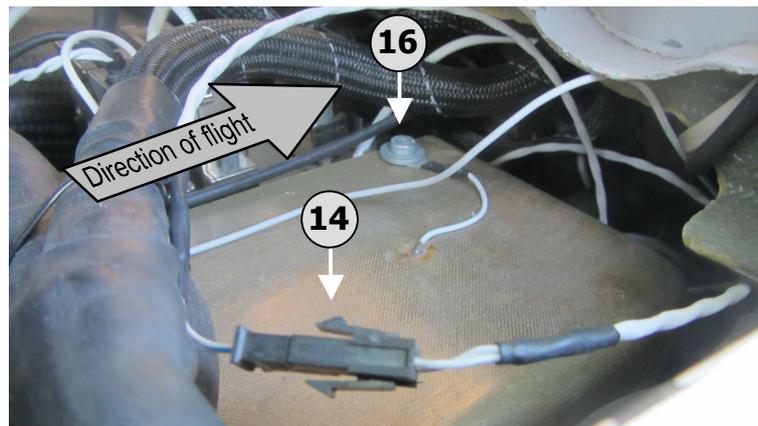
Use the picture above to identify the forward top screw connection (16) on the power electronics enclosure. Depending on the screw type, use a 3 or a 4mm Allen wrench to remove this M5 Screw including washer.

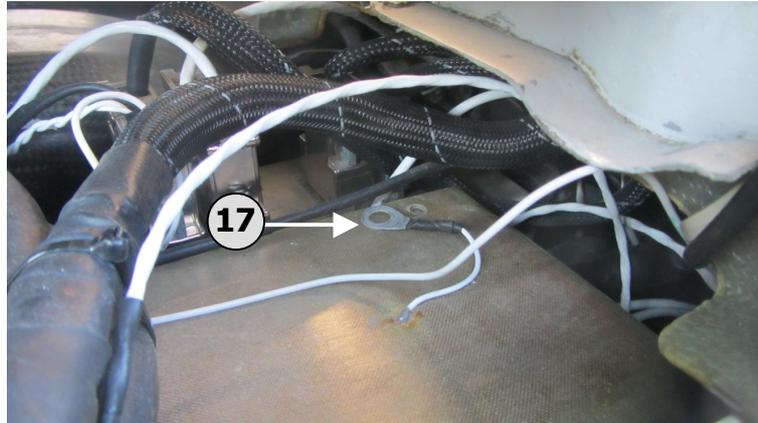
It is possible that removing this screw connection will release one or more shield connections (17).

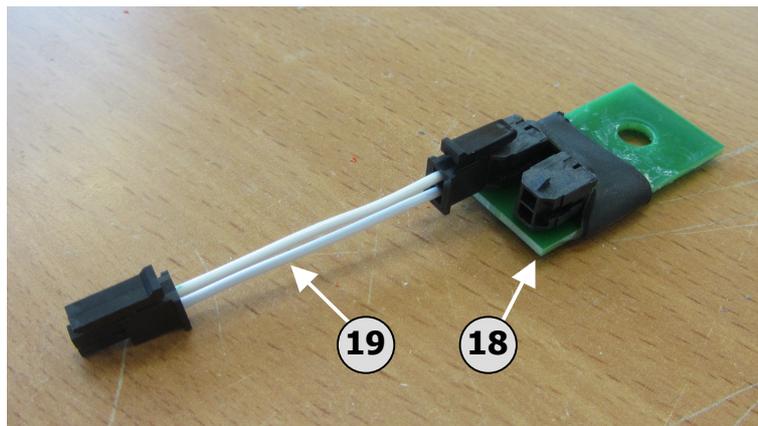
- c. Equip the capacitor PCB (18) with adapter-cable 1 (19).

Note: The capacitor-PCB contains two female connectors. These are functionally- and pin-equivalent. There is no danger of incorrect installation.

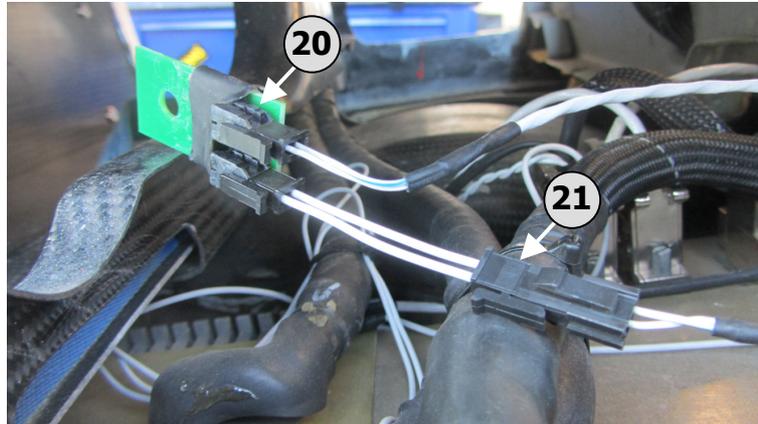
Open the disconnection point (14)

Plug the male connector (20) into the fitting female connector directly on the capacitor PCB. Plug the male connector (21) on adapter-cable 1 into the fitting female connector.

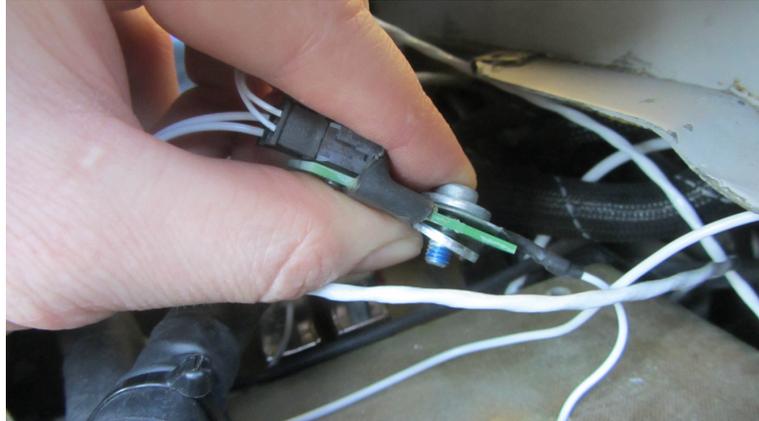
If the procedural Step 3b resulted in the release of no, or only one shield connection, then stack the parts that need to be secured in the following way:

- > Hexagon socket screw with low head - M5x12
(supplied as a part of the kit) (22)
- > Washer - M5 (supplied as a part of the kit) (23)
- > Shield connection (if released in procedural step 3b) (17)
- > Capacitor PCB (18)
- > Washer - M5 - DIN 9021 (23)

If the procedural Step 3b resulted in the release of more than one shield connection, then stack the parts that need to be secured in the following way:

- > Hexagon socket screw with low head - M5x16
(supplied as a part of the kit) (22)
- > Washer - M5 (supplied as a part of the kit) (23)
- > Shield connections (17)
- > Capacitor PCB (18)
- > Washer - M5 - DIN 9021 (23)

Apply a small amount of medium strength threadlocker (24), Loctite 243 blue, to the exposed thread. Take care not to apply so much threadlocker that it can creep up into the electrical connection.

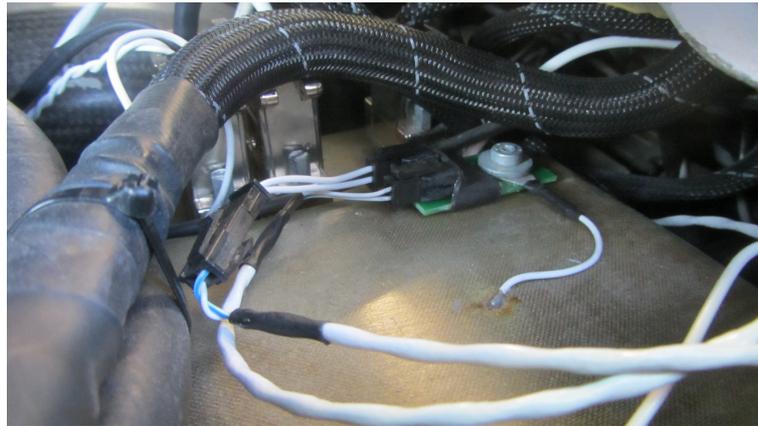
Attention: If the screw is too long, and the thread end collides with the heat-sink of the power electronics (the screw can not be screwed in any further, but the PCB can easily be rotated around the screw), then one more washer should be added underneath the screw head.

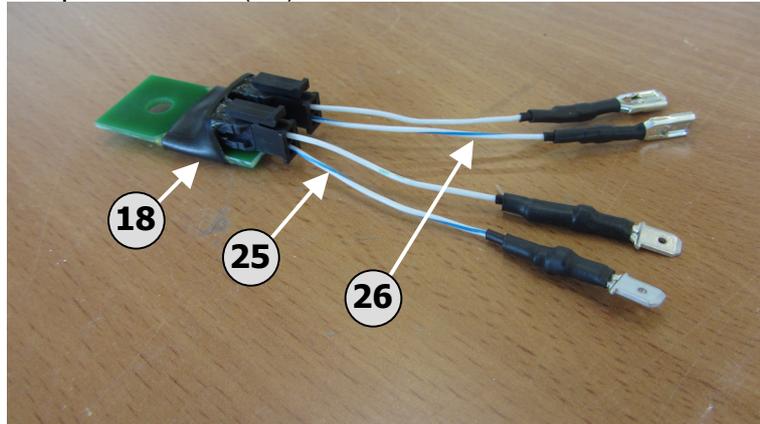
4. Install the capacitor PCB in the alternate position
 - a. Equip the capacitor PCB (18) with adapter-cable 2 (25) and adapter-cable 3 (26)

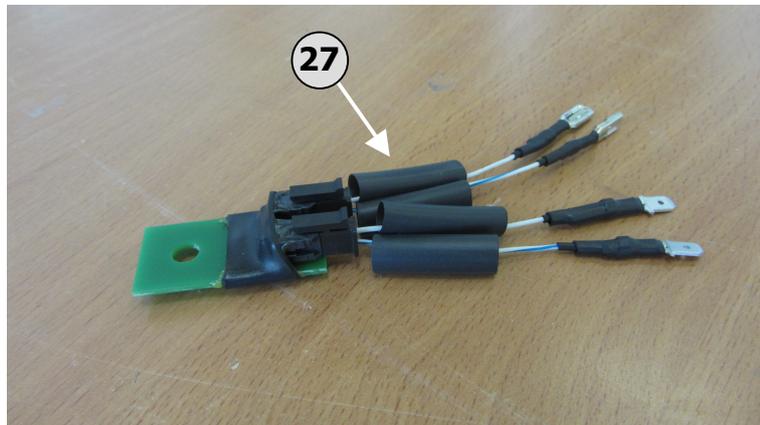
- b. Slide one length of heat-shrink-tube (27) over each cable end of the adapter-cables.

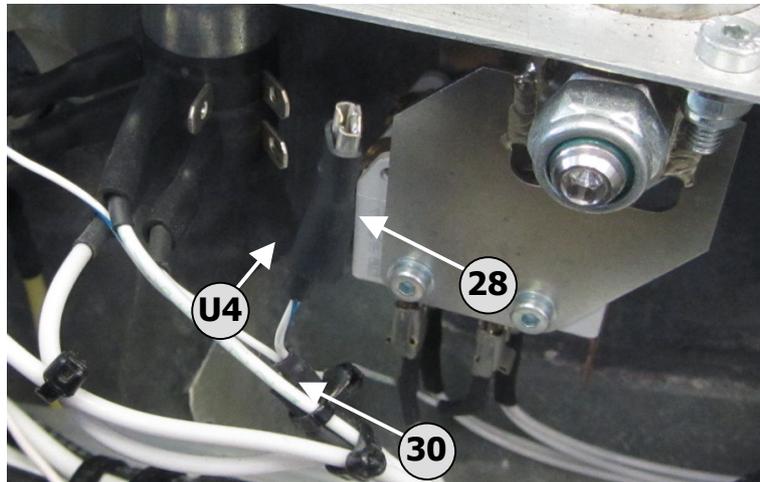
- c. Start by disconnecting the cable lug (28) located in plug position (U4) of the key-switch. Press down the release tab (29) in order to unlock the cable lug.

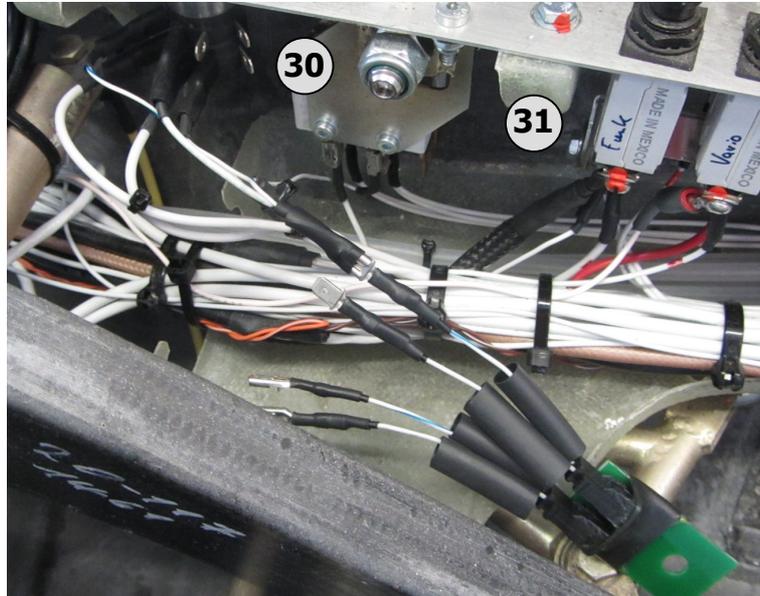
- d. Connect the now exposed white-blue wire (30) with the white blue wire of adapter-cable 2 (31).

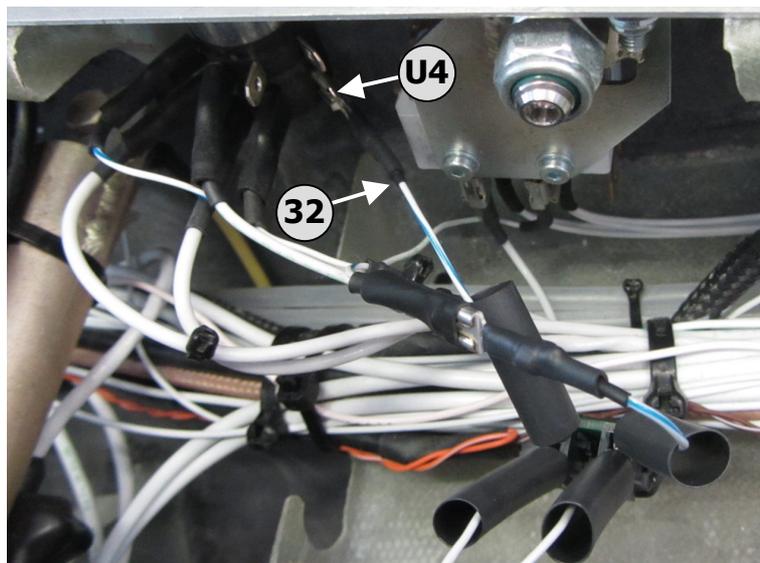
- e. Connect the white-blue striped cable of adapter-cable 3 (32) to plug position (U4) of the key-switch.

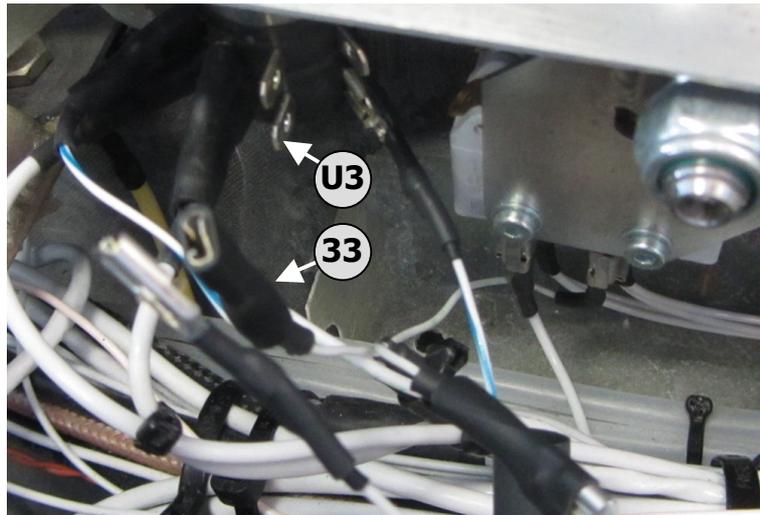
- f. Disconnect the cable lug (33) located in plug position (U3) of the key-switch.

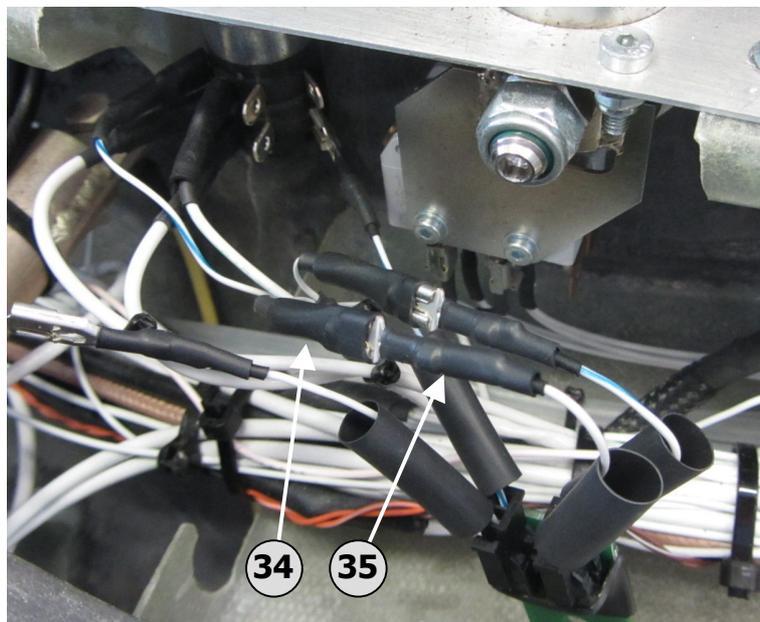
- g. Connect the now exposed white wire (34) with the white wire of adapter-cable 2 (35).

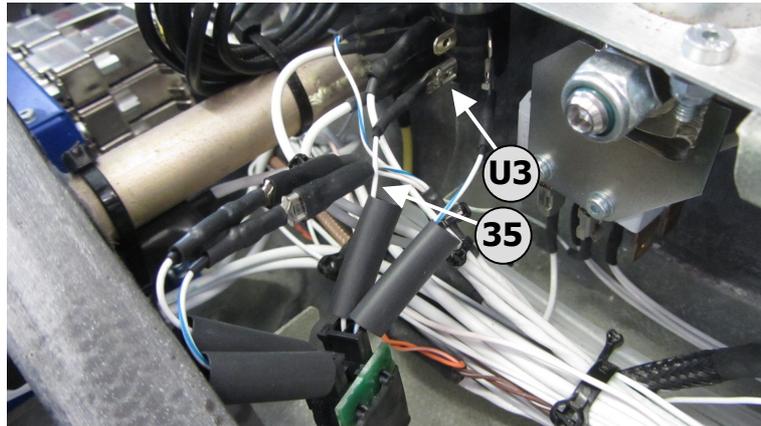
- h. Connect the white striped cable of adapter-cable 3 (35) to plug position (U3) of the key-switch.

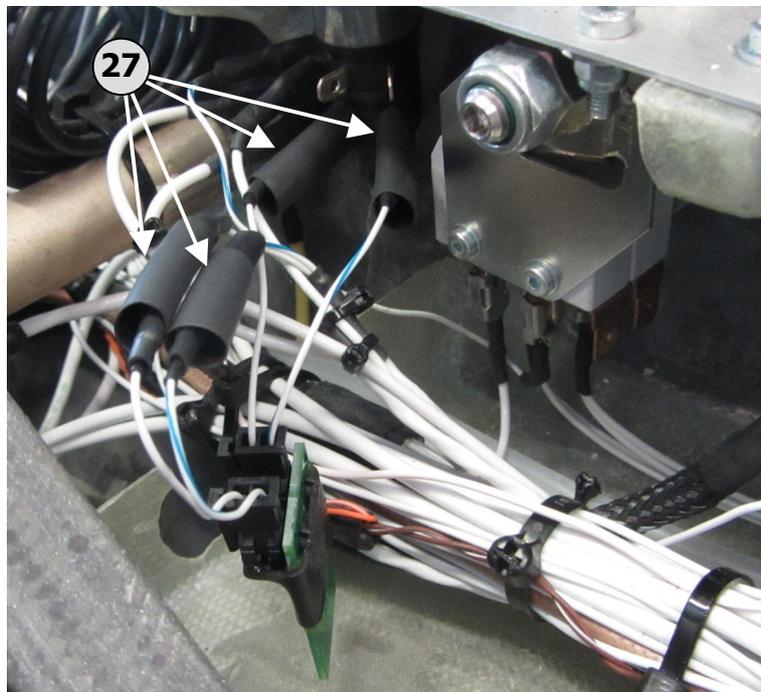
- i. Slide the four lengths of heat-shrink tube (27) that were introduced in procedural step 4a over the connections that were made in procedural steps 4d, e, g and h.

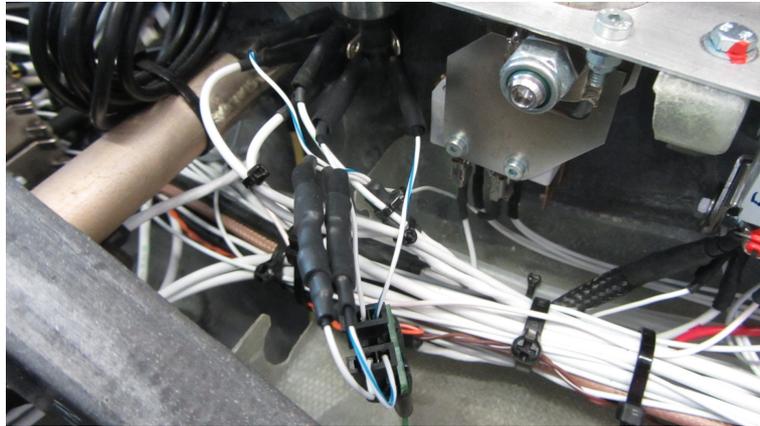
- j. Use a hot-air gun to shrink the four lengths of heat-shrink tube.

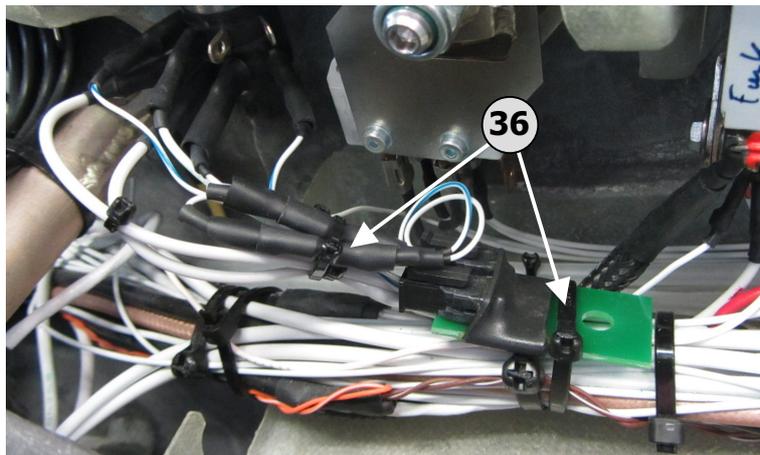
- k. Use the enclosed cable ties (36) to secure the capacitor PCB and to re-route the wires tidily
