TN 904-5

Subject: Shaft-coupling in pump-unit

Affected:: E1 Antares, 1 to 60E49

Date: 20.03.2014

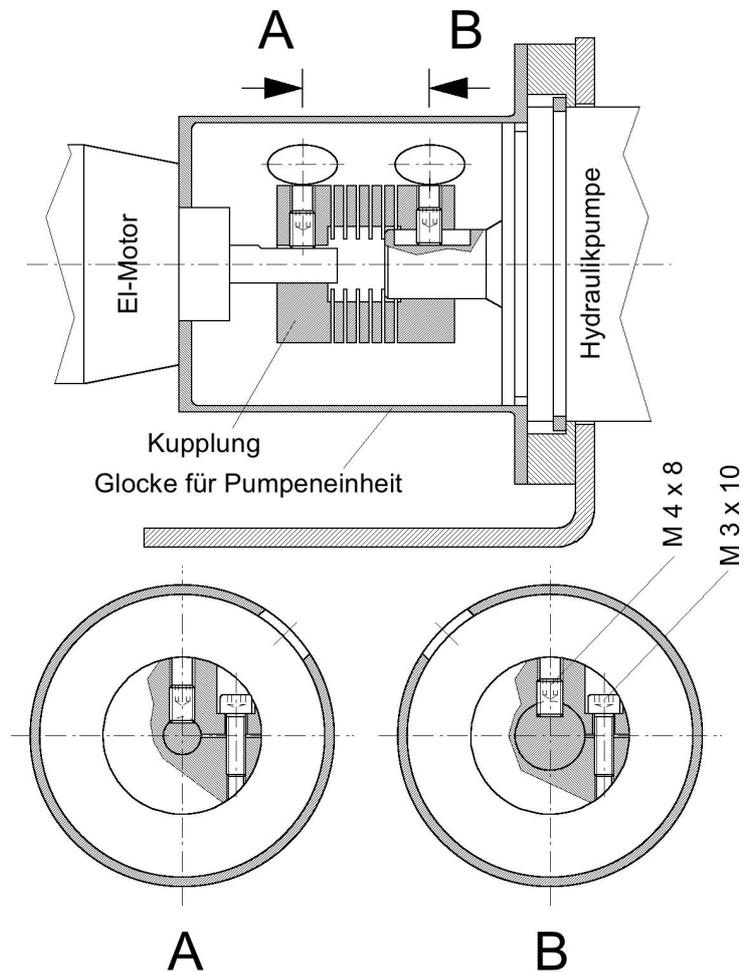
Attention: In some aircraft the coupling enclosure apertures are hand-made. Therefore, these may to some degree vary from the picture.

Use a 2.5 mm and a 3 mm Allen wrench to loosen the two screws in cross section A of the old coupling.

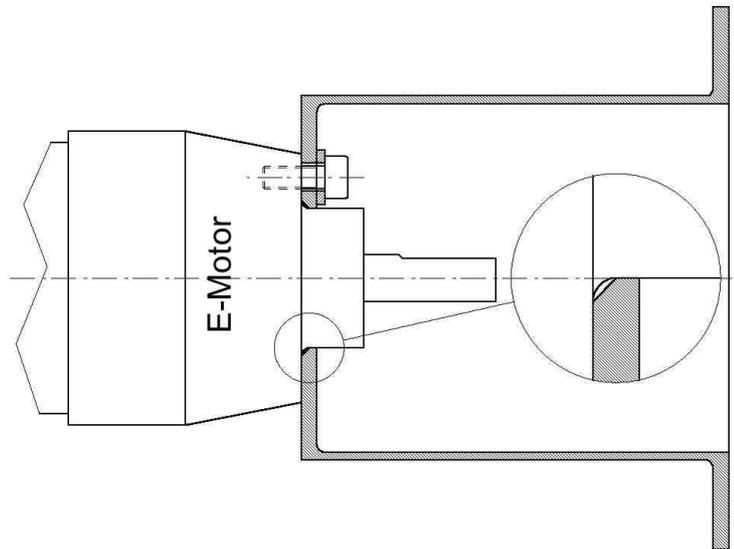
Check whether there is a gap between the motor and the coupling enclosure. If this is the case, then use a 2 mm Allen wrench to remove the four M3 x 8 screws (15), which connect the motor and the coupling enclosure.

Separate the motor from the coupling enclosure and use a 90° countersink tool to fit the edge of the coupling enclosure to the radius at the motor. Before re-assembly: check the length of screws (15) (Screw length should be 8 mm). Re-install the motor. Use medium strength threadlocker (Loctite 243) on the screws and apply inspection lacquer
